HOLDEN CONSERVATION LTD

Kensal Green Cemetery

Conservation Report on the monument to Emma and Alexis Benoît Soyer

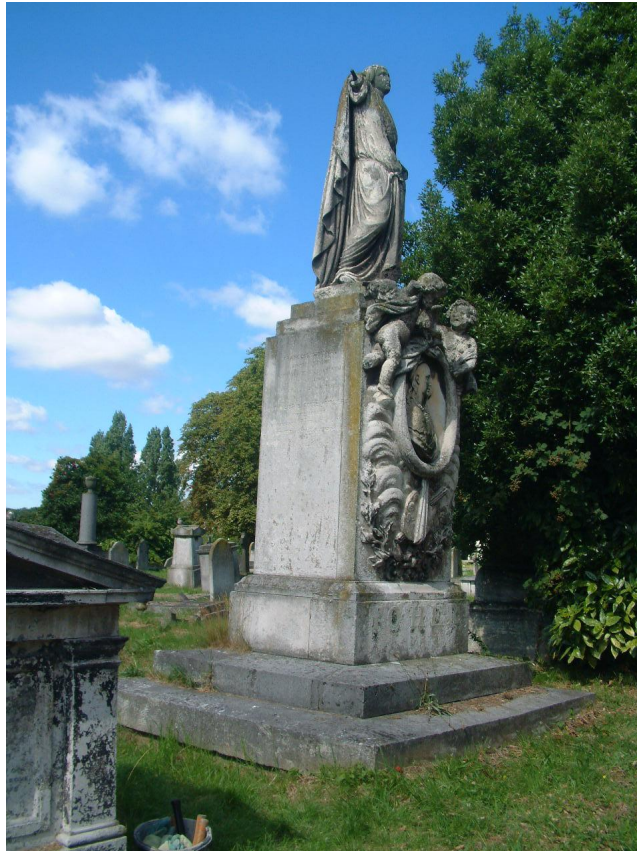
1 Soyer Memorial, Kensal Green Cemetery – before conservation.

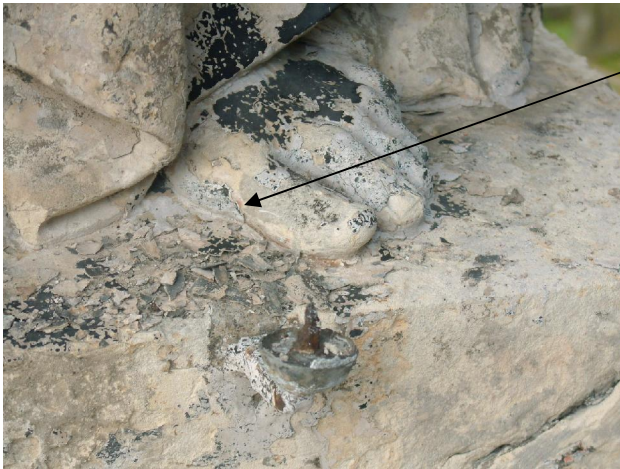
1. The loose paint layers on the stone work.

Loose paint flakes were brushed from the surface of the stone.

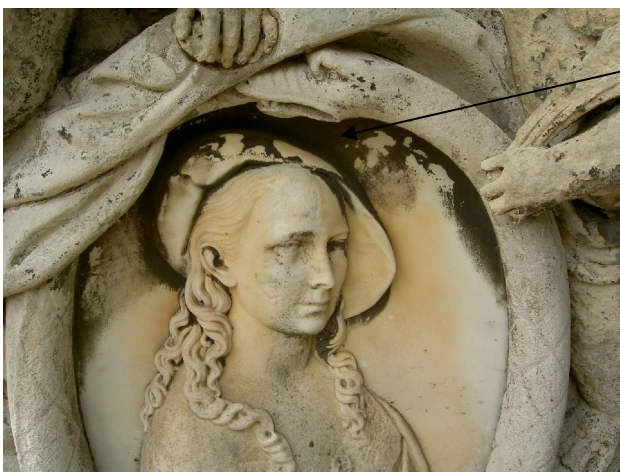
2. The sulphation on the marble portrait before poulticing.

Three clay poultices of 'Sepiolite' and water with 10% ammonium carbonate were applied to the marble portrait and left over night. The sulphation was removed with bristle and bronze brushes.

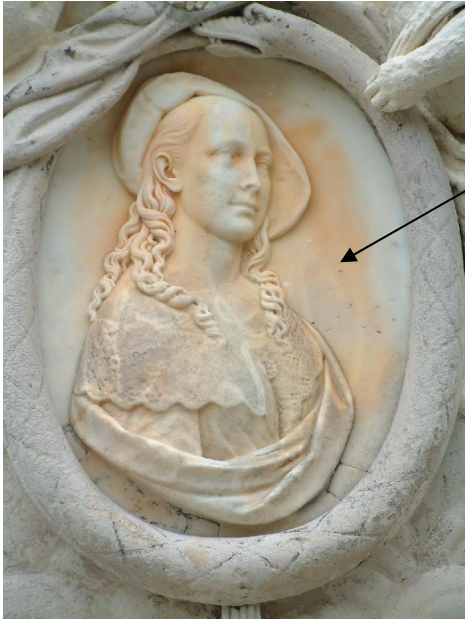
3. The marble portrait after poulticing.

The orange staining was not reduced by the ammonium carbonate poultice.

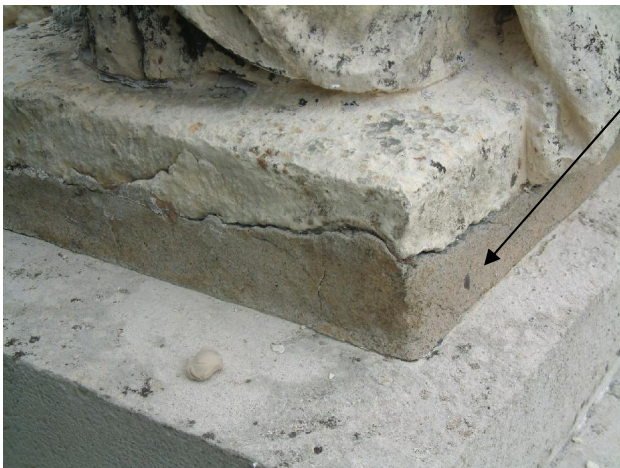
4. The failed cement repair to the base of Faith, before removal.

The failed cement repair to the base of the Faith sculpture was removed using hand tools and re-built in a hydraulic lime mortar. The repair was built up with a coarse backing mortar before a fine top layer of mortar was applied, to match the Beer stone.

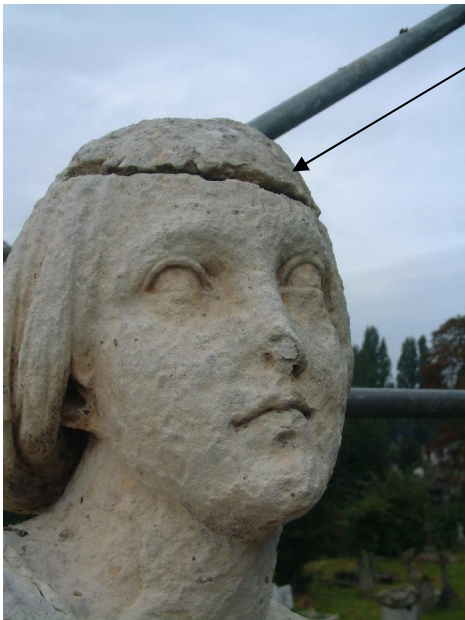
6. The loose section of Faith's head before repair.

The loose section on Faith's head was repaired. The old adhesive was cleaned off both sides of the break edges and the piece re-adhered with a 6mm threaded stainless steel stud and Steinkitt polyester resin.

The joint was then filled with a hydraulic lime mortar to match the Beer stone.

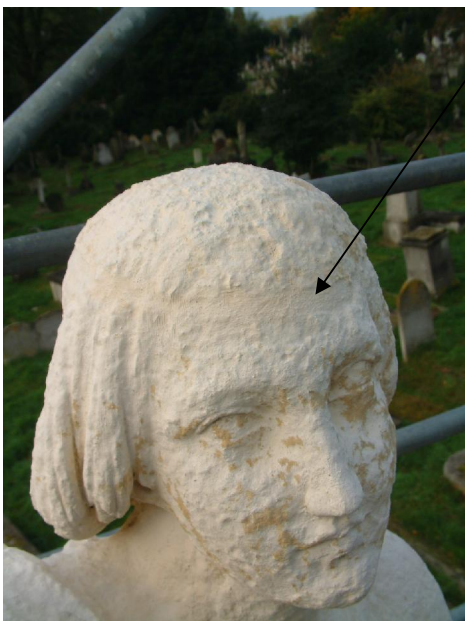
7. The finished repair to Faith's head, after two coats of lime wash (lime wash still wet).

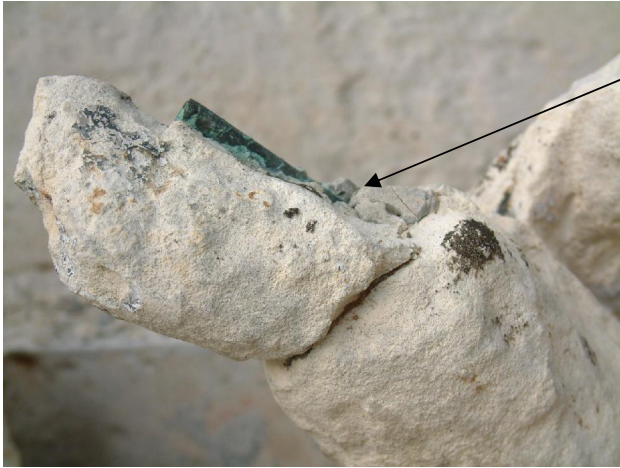
8. The right side cherub's right hand proper before the bronze dowel and cement were removed.

The broken pieces of the right side cherub's right hand proper were re-adhered in position. First the remaining bronze dowel and cement were removed using hand tools and a drill.

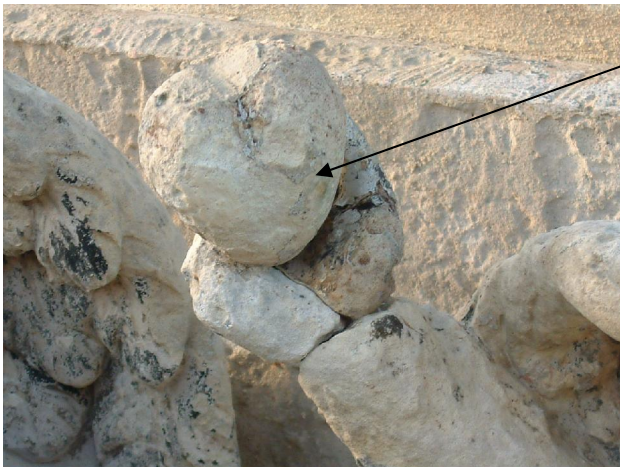
9. The pieces of the right side cherub's right hand proper re-adhered in position.

The sections of the hand were re-adhered using a 6mm threaded stainless steel dowel and Steinkitt polyester resin.

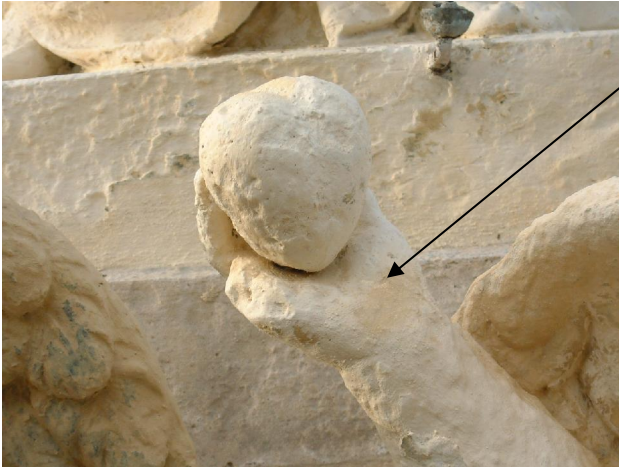
10. The finished repair to the right side cherub's right hand proper, after 2 coats of lime wash.

The missing part of the hand, except for the fingers was built up in hydraulic lime mortar to match the Beer stone.

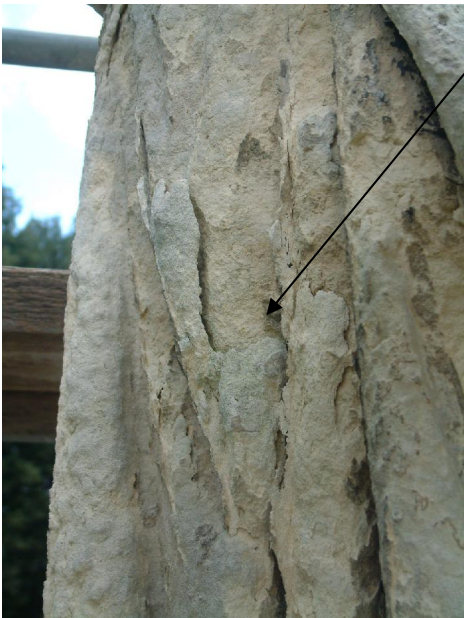
11. Detail of a section of Faith's drapery showing the cracked and flaking stone before dentistry mortar repairs were carried out.

Dentistry hydraulic lime mortar repairs were carried out on all water traps, cracks, blistering surfaces and break edges.

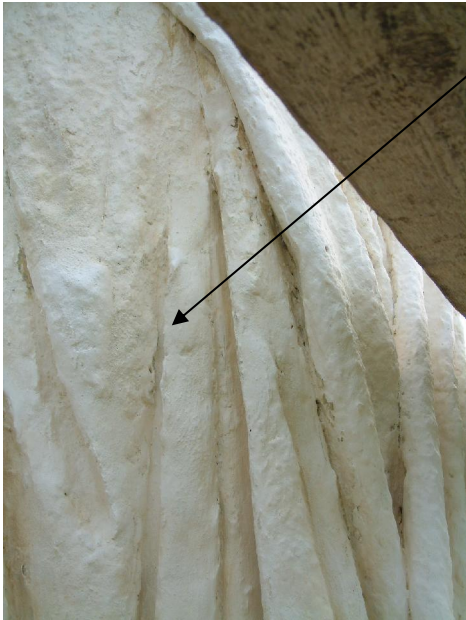
12. Detail of a section of Faith's drapery after dentistry mortar repairs and 2 coats of lime wash.

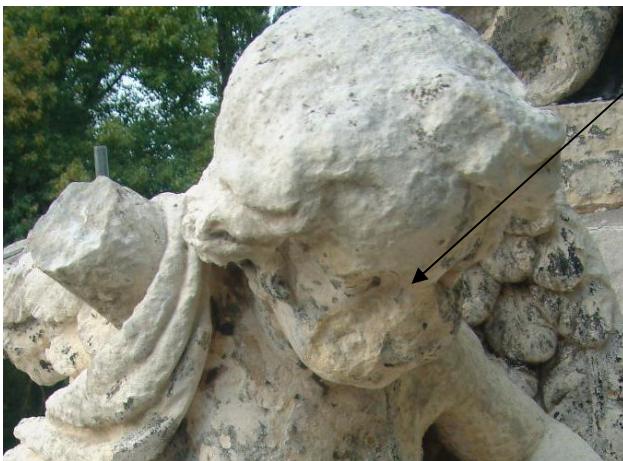
13. The deteriorated carved detail on the head of the left side cherub before mortar repairs were carried out.

Mortar repairs were also undertaken to partially restore details to the heads of Faith and the cherubs.

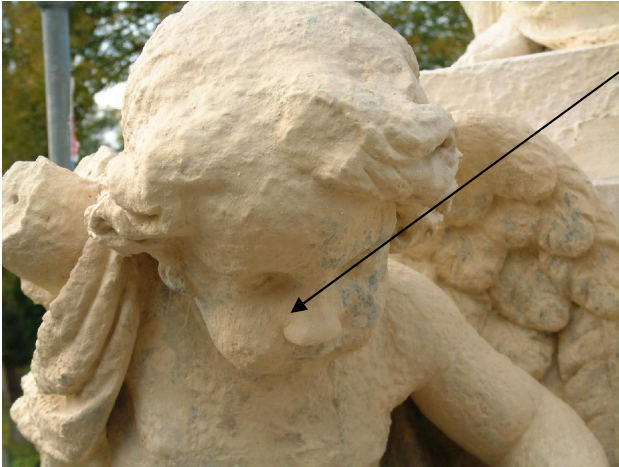
14. The head of the left side cherub after mortar repairs were carried out. The lime wash coat is still wet.

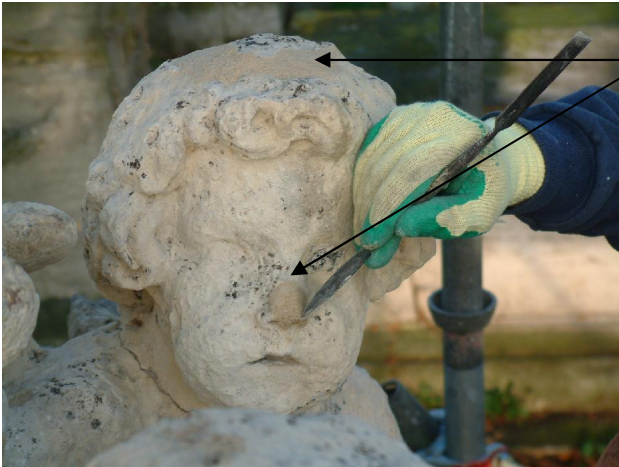
15. Mortar repairs being carried out on the deteriorated carved detail of the right side cherub.

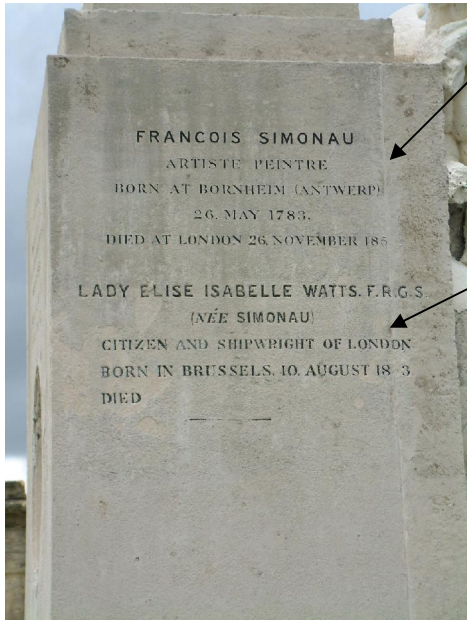
17. The re-painted lettering on the upper half of the East side plinth.

The partially re-painted lettering on the lower half of the East side plinth.

The incised lettering on the upper half of the East side and South (rear) side of the plinth was re-painted in a matt, black oil paint.

Some of the more worn incised letters on the lower half of the East side of the plinth were re-cut with a chisel to enable them to be re-painted. The lettering on the lower half of the East side of the plinth was partially re-painted in a matt, black oil paint to enable the lettering to be legible.

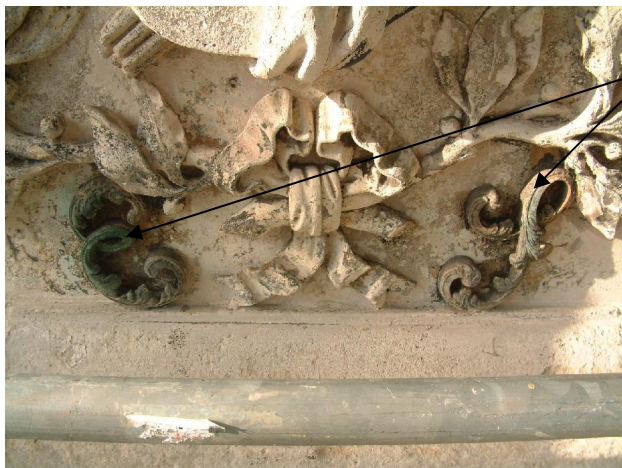
18. The bronze letters 'E' and 'S' before the removal of the old paint layers.

The old paint on the bronze letters 'E' and 'S' was removed with Nitomors and bristle brushes. A coat of microcrystalline wax was then applied to the letters.

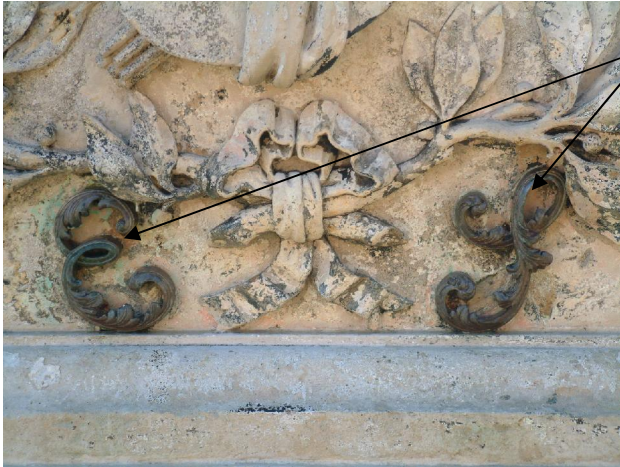
19. The bronze letters after paint removal and waxing had been carried out.

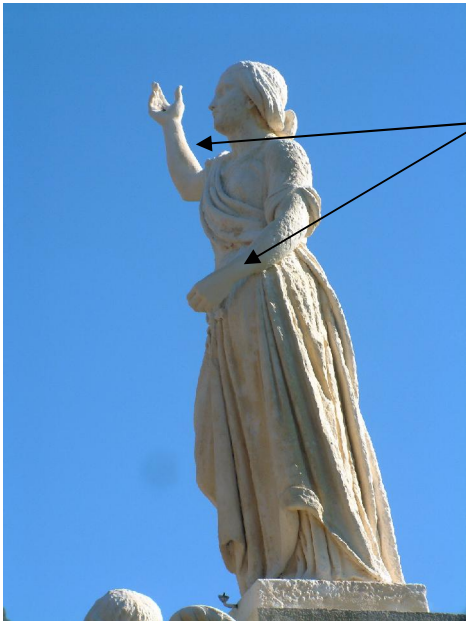
20 The completed sculpture of Faith after the final lime wash coating.

The new right arm proper and left hand proper.

The new stone limbs were fixed in position with threaded stainless steel dowels and Steinkitt polyester resin. The joints were filled with a hydraulic lime mortar to match the Beer stone.

A final coat of lime wash was then applied to all of the figures.

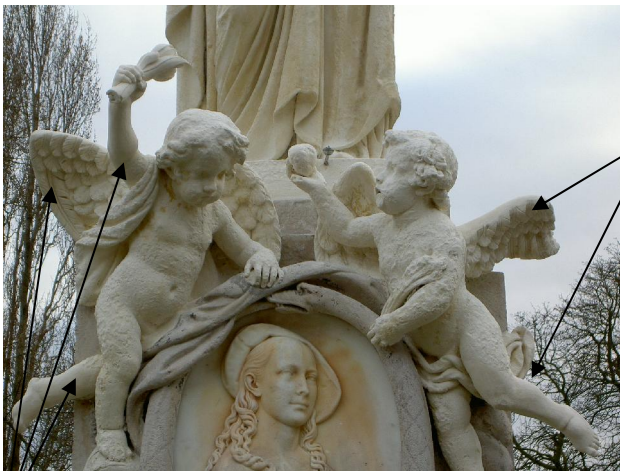
21 The completed cherubs after the final lime wash coating.

The new left wing proper and left leg proper.

The new right wing proper, right arm proper and left leg proper.

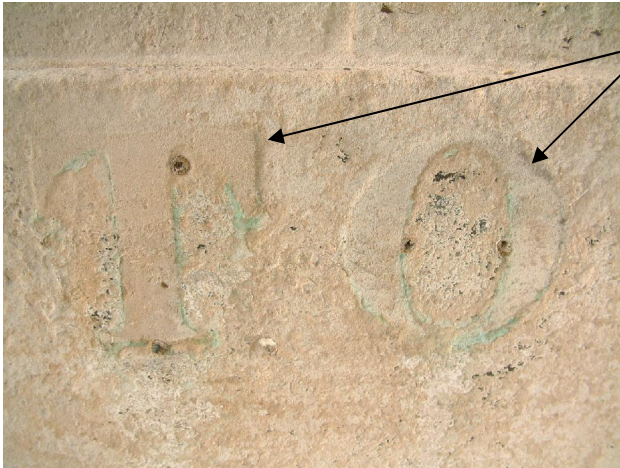
22 The outline of the original bronze letters 'TO HER'.

A tracing of the outline of the original position of the missing bronze letters 'TO HER' was taken and from that a new set of bronze letters were cast. The bronze letters were supplied by David Odgers. The new letters were attached in position with stainless steel studs secretly located in the rear of each letter and set into new drilled holes using Steinkitt polyester resin.

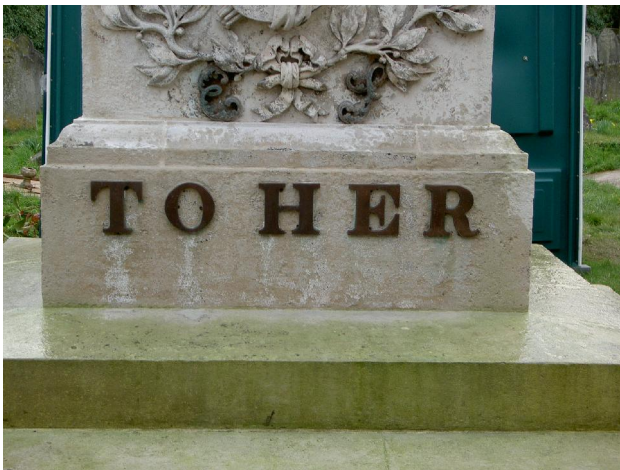
23 The new bronze letters 'TO HER' in position.

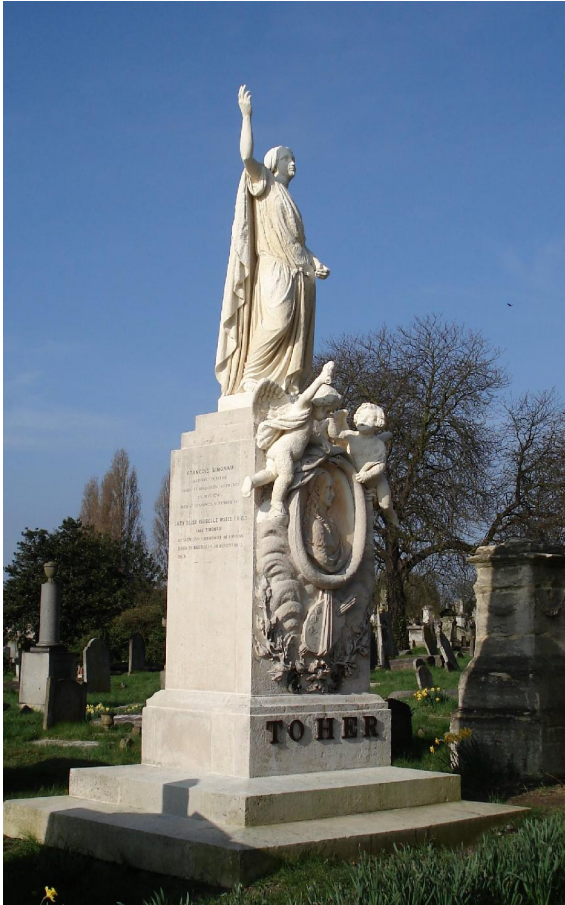
24 The completed Soyer Memorial
