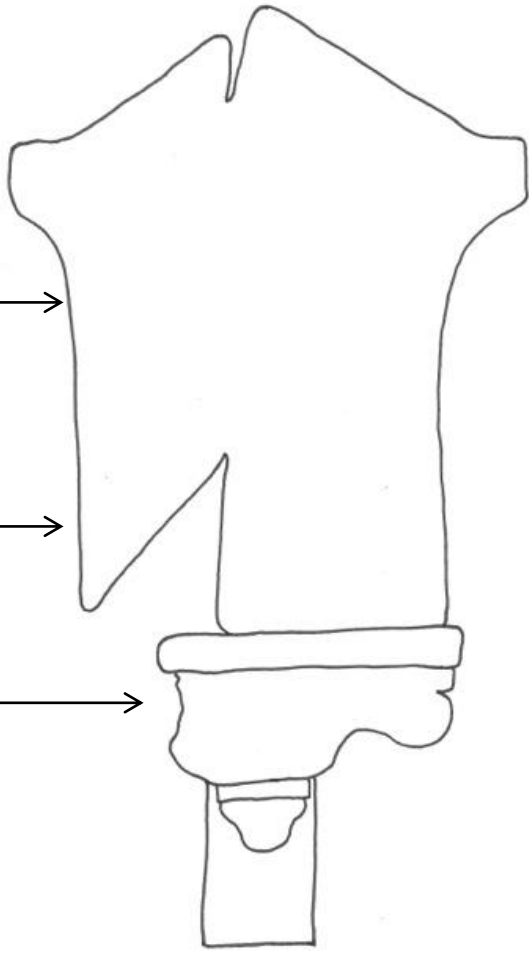
**Option 1.**

The memorial and the inscription are very worn, which would be emphasised if the memorial were re-sited inside.

To re-position the remaining sections of the memorial on the wall without undertaking any re-building of the memorial in either lime mortar or stone.

The sections of the memorial will be re-adhered and the joints filled with hydraulic lime mortar.

The missing section of the inscription panel will not be made up with a stone indent repair.

The missing section of the carved stonework will not be replaced.
